Engineering Design: Insights into Highway Bridge and Tunnel Disasters

INCOSE – Chesapeake Chapter
August 20, 2014
Laurel, MD

Earl F. Weener, Ph.D.
Member, NTSB

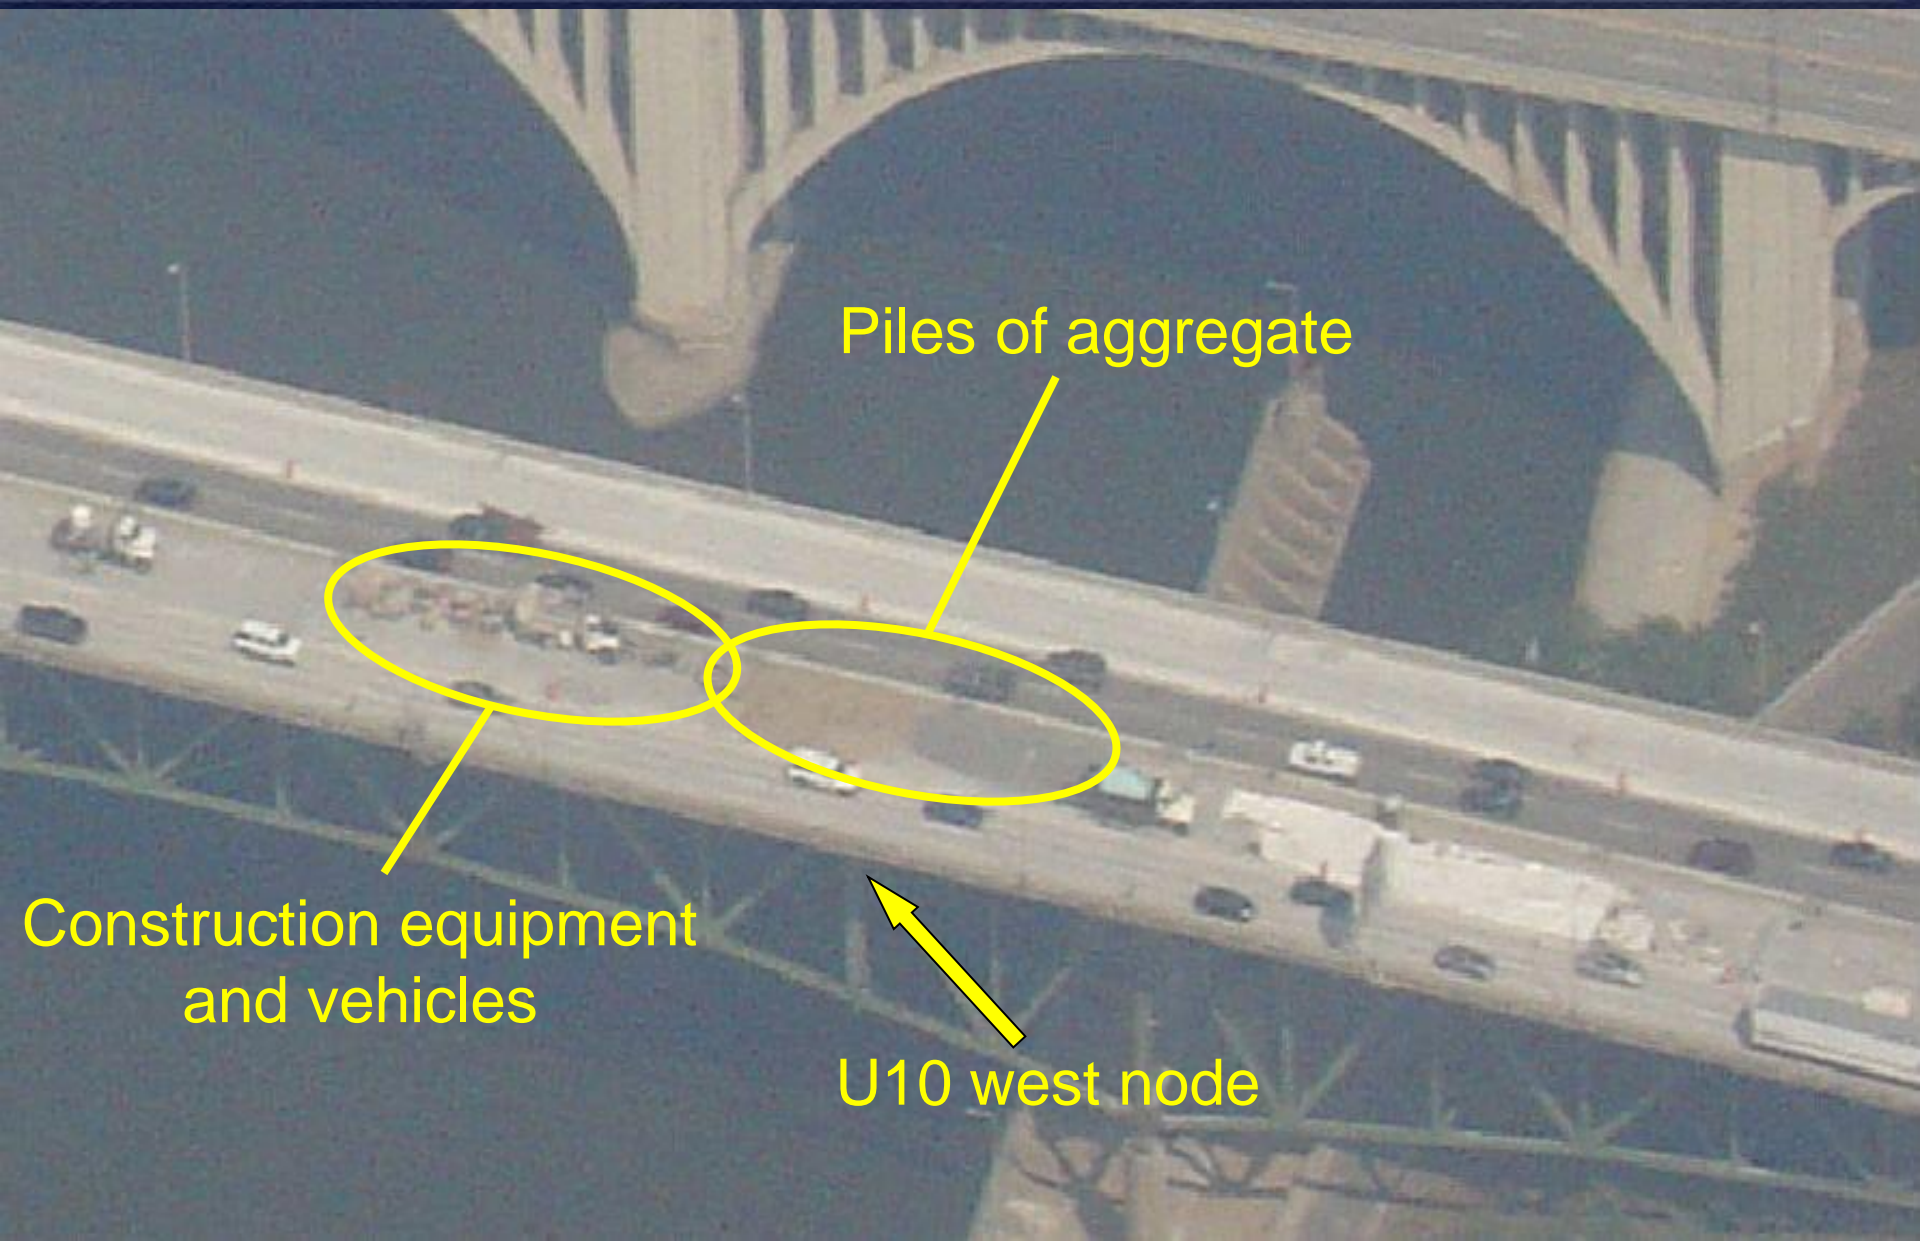
Construction Work – Day of Accident

- 1) Substantial increases in the weight of the bridge, resulting from previous bridge modifications; and
- 2) Traffic and concentrated construction loads on the bridge the day of the collapse.

Piles of aggregate

Construction equipment
and vehicles

U10 west node

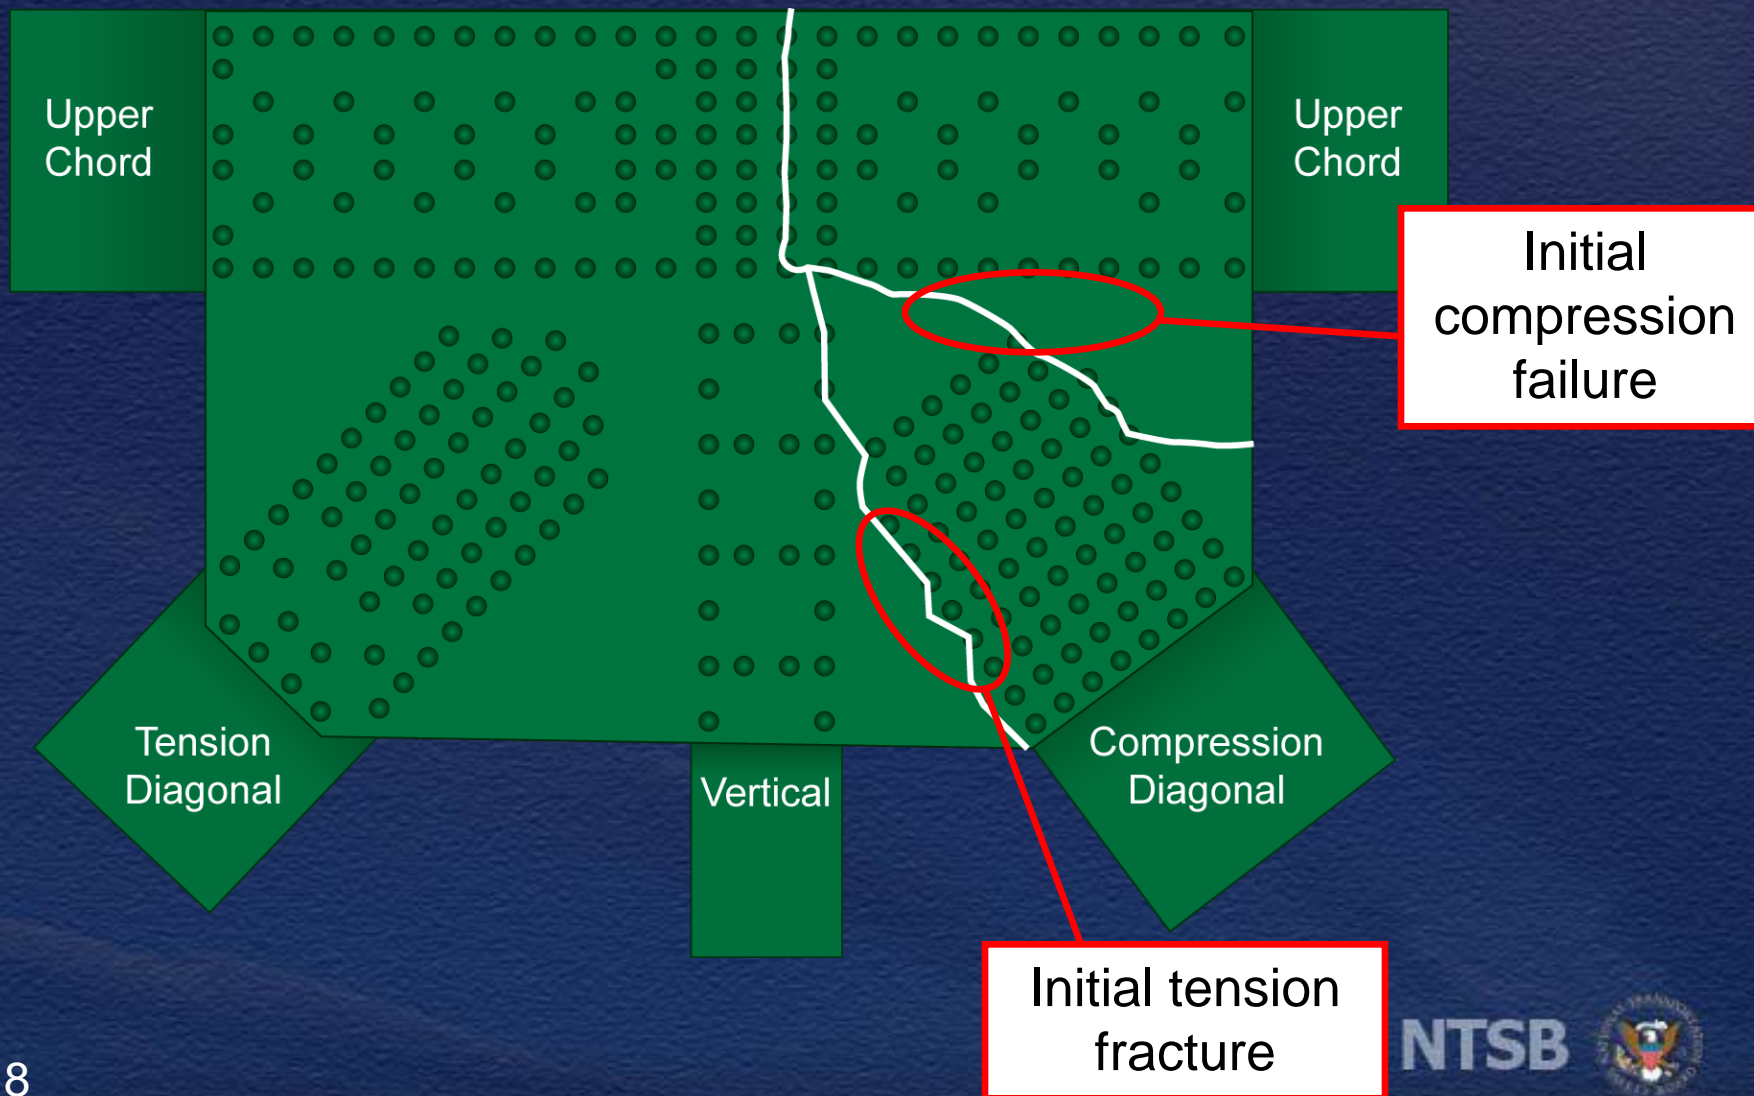
Drawing of Fractures in Node U10E West Gusset Plate

The inadequate load capacity, due to design error of the gusset plates at the “U10” connection points by the engineering consulting firm responsible for the bridge design, which failed under a combination of:

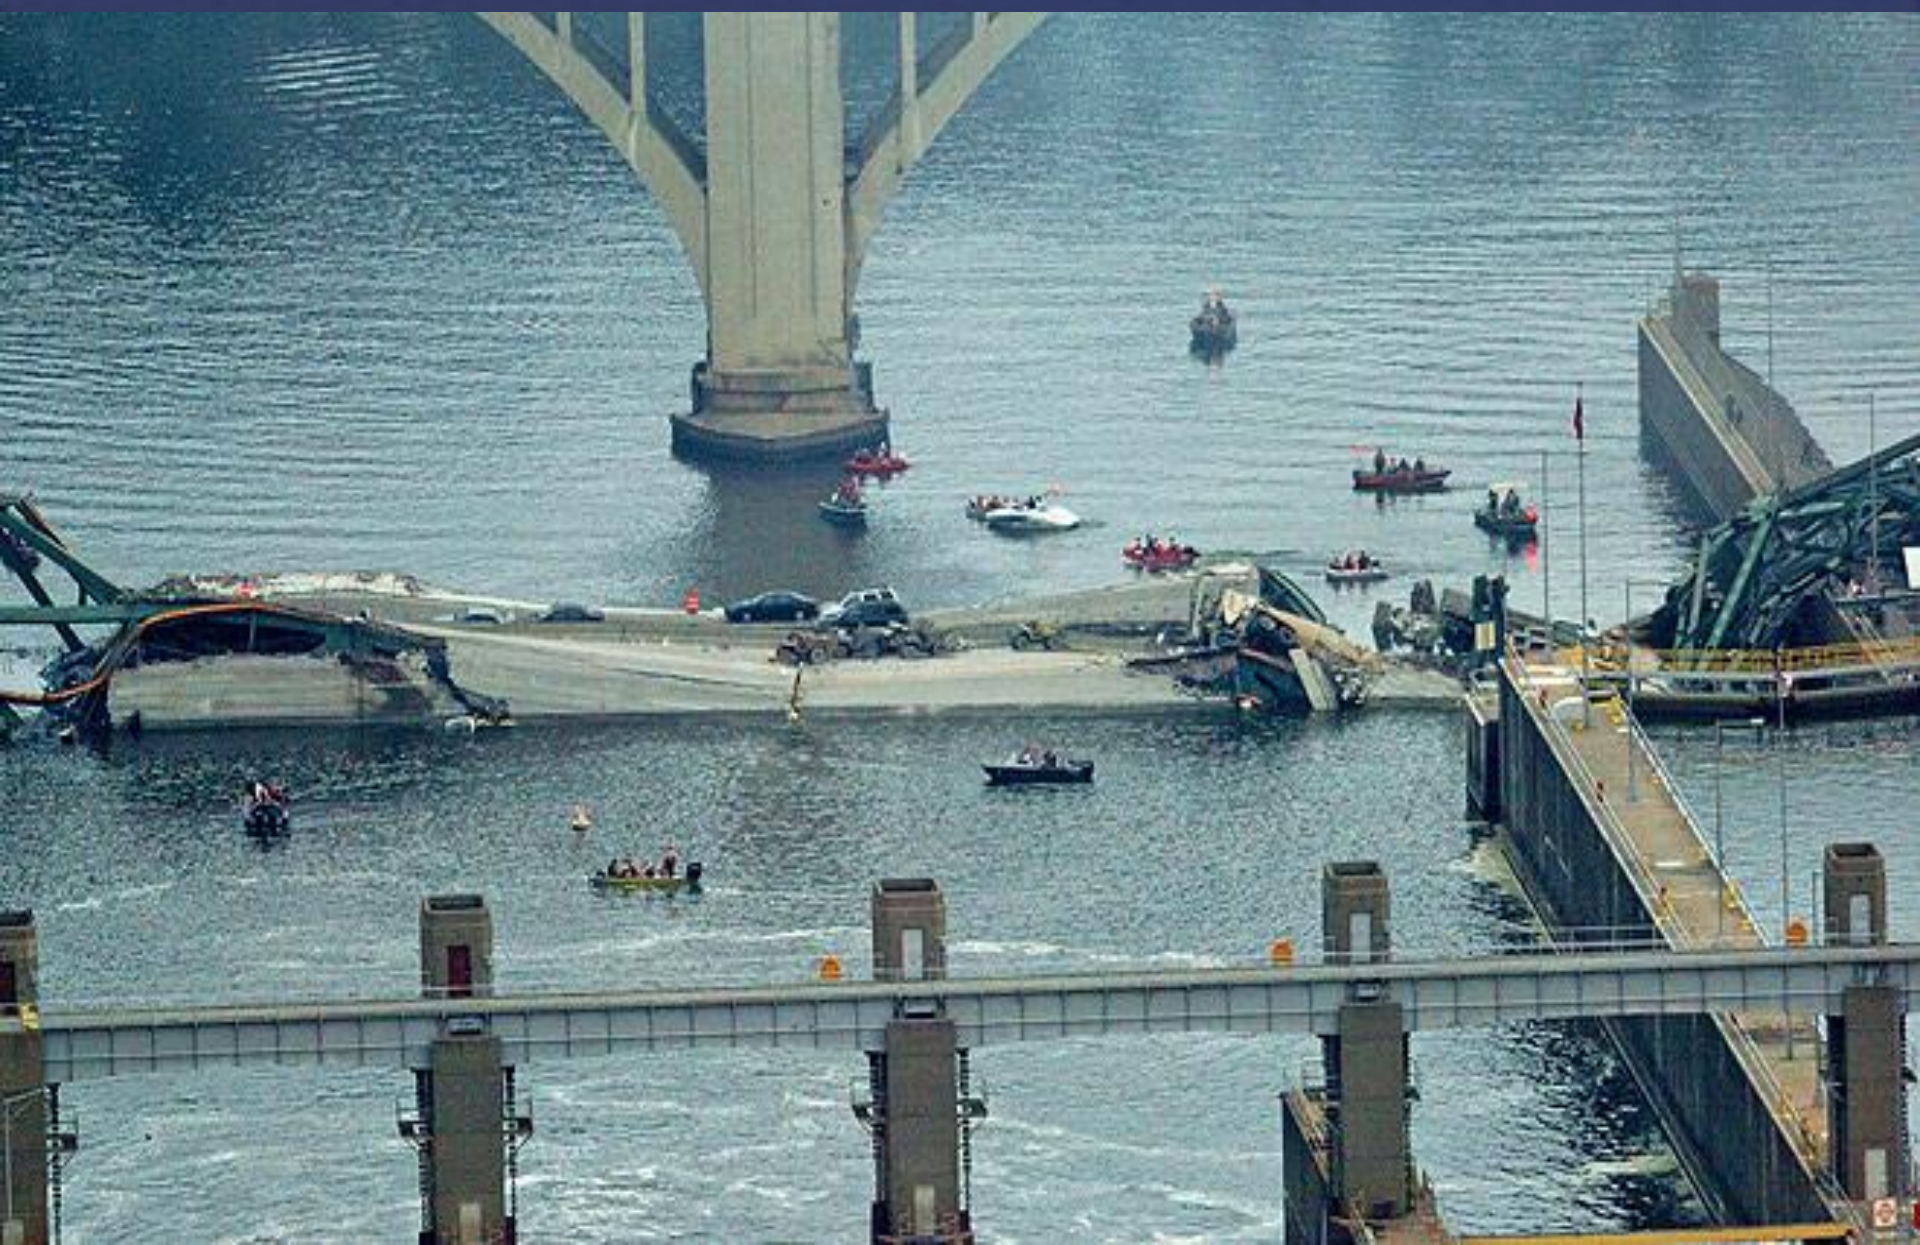
U10 West

Has higher stress
at the time of the
accident

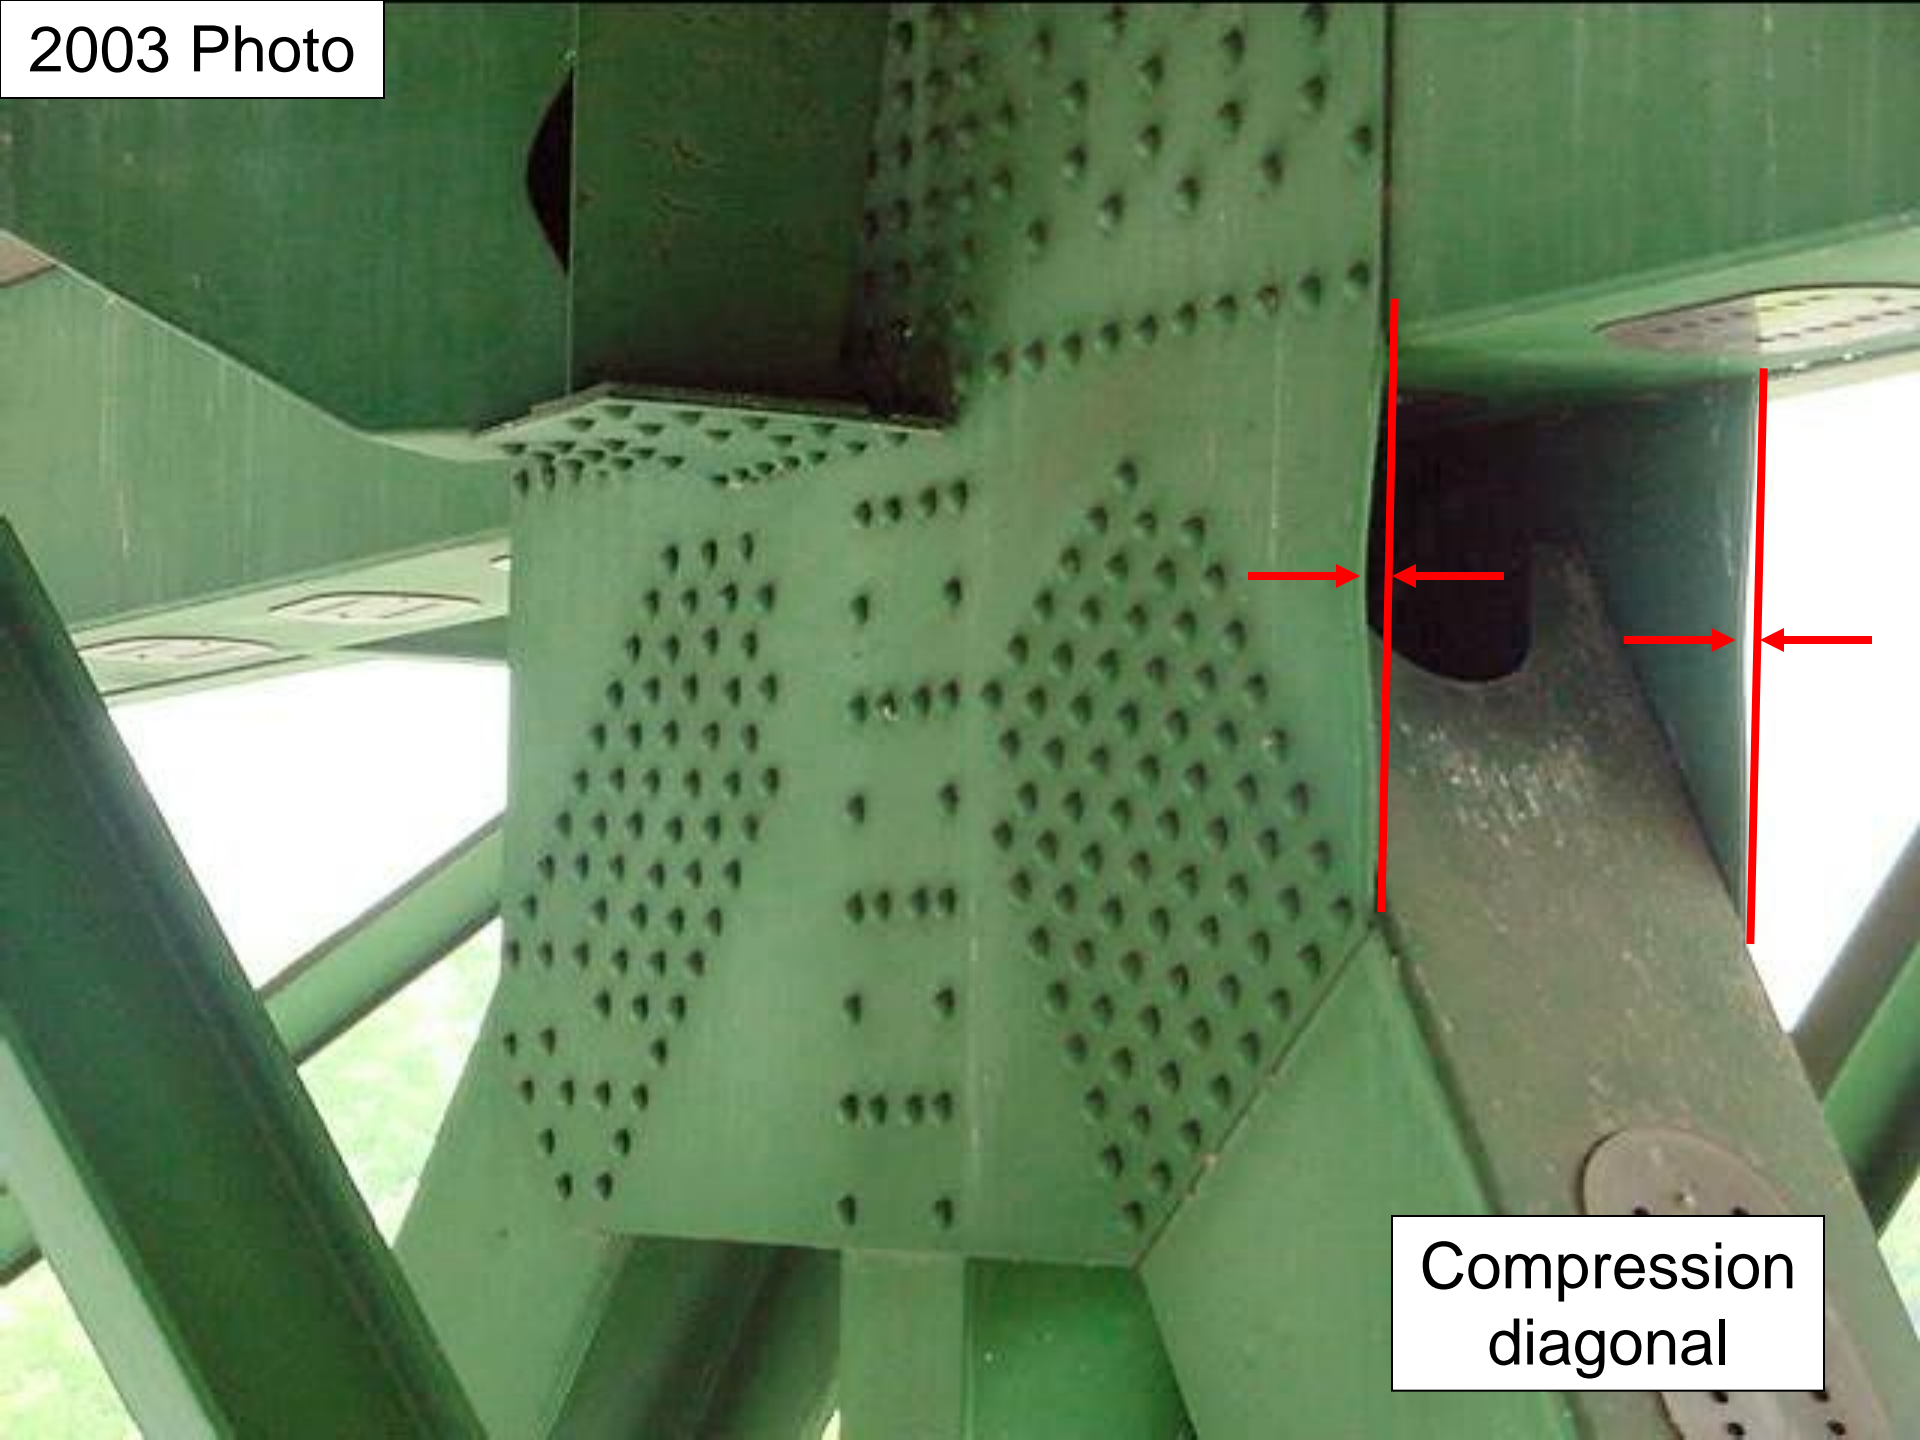
2003 Photo

Compression
diagonal

- Design, construction, and inspection guidance materials focused on members and other structural elements only.
- Bridge safety inspection engineer – noticed, but made poor assumptions and did not document.
- Evaluations by URS/U. of Minnesota, failed to identify bowing condition, although captured photographic evidence.
- Decision to allow staging of aggregates on bridge deck truss.

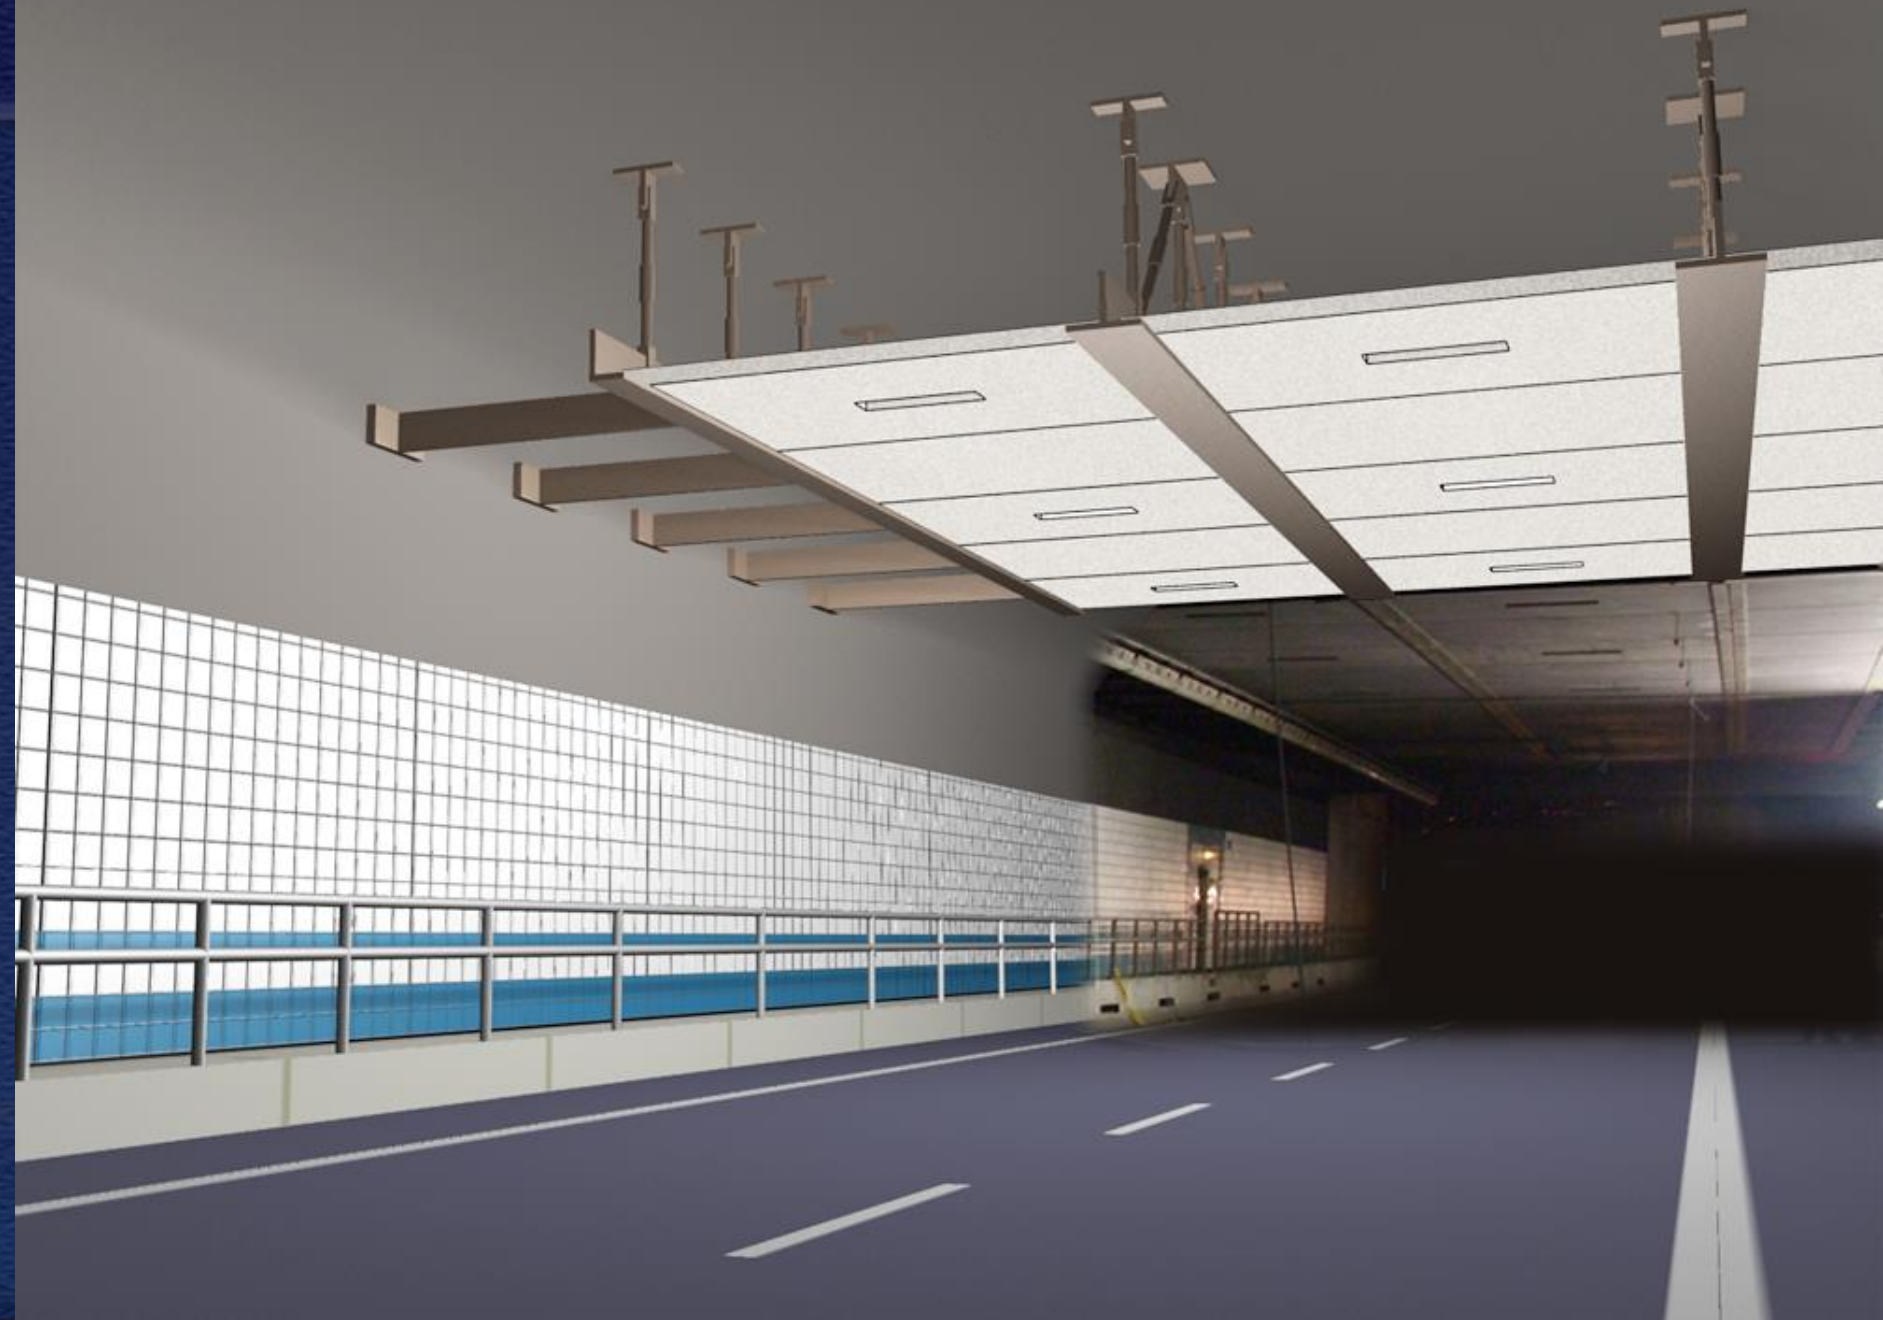
Displaced Anchors

The use of an epoxy anchor adhesive with poor creep that could not sustain long-term loads.

- Failure of the epoxy provider to identify the unsuitability of the epoxy in a previous anchor application.
- Failure of project contractors to continue to monitor the anchors, after the first instance of anchor displacement.
- Failure of the Turnpike authority to implement an inspection program.
